The Road Inventory of Conboy Lake National Wildlife Refuge Glenwood, WA

Prepared By:
Federal Highway Administration
Central Federal Lands Highway Division
April 2013

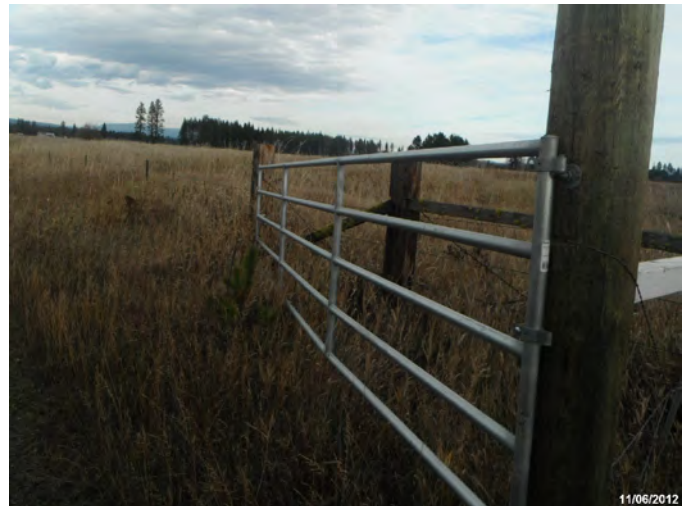
Photo: COLA_C4_0559 Route: 100-001-0.0
Metal Open Rail Gate
Asset# NA

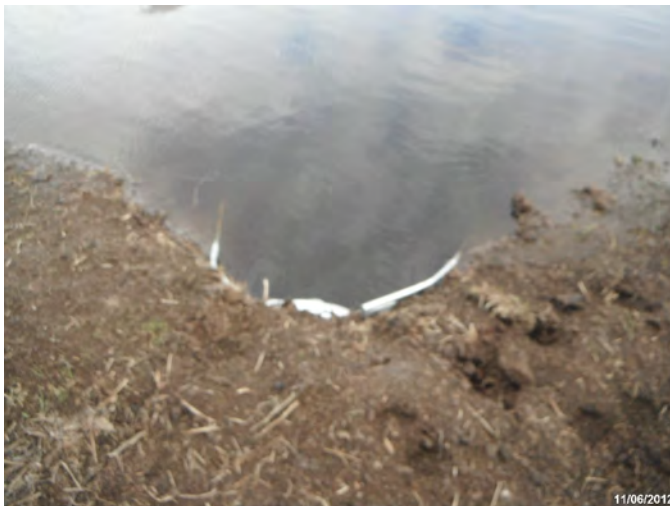
Photo: COLA_C4_0560 Route: 100-001-0.61
Metal WCS Flap Gate/Full-Round Riser 40ft long 36in dia.
1ft deep Asset# NA

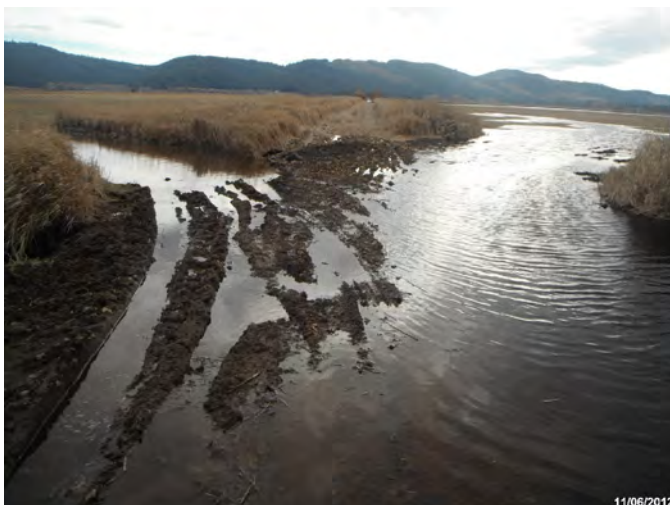
Photo: COLA_C4_0562 Route: 100-001-0.77
Problem Area Water over road unable to pass

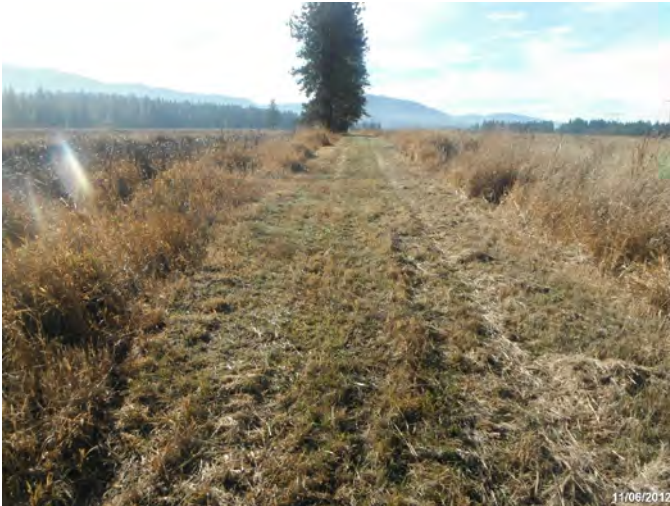
Photo: COLA_C4_0482 Route: 402-001-0.0
Problem Area Route underwater at this point

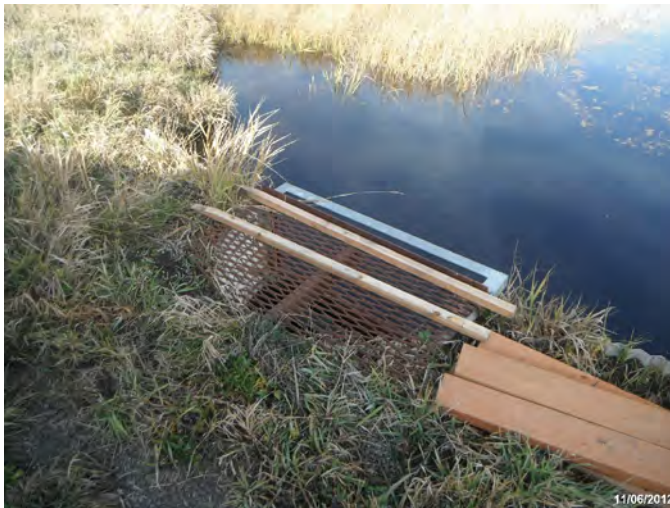
Photo: COLA_C4_0527 Route: 402-005-4.8
Metal WCS Flashboard Riser 30ft long 36in dia. 3ft deep
Asset# NA

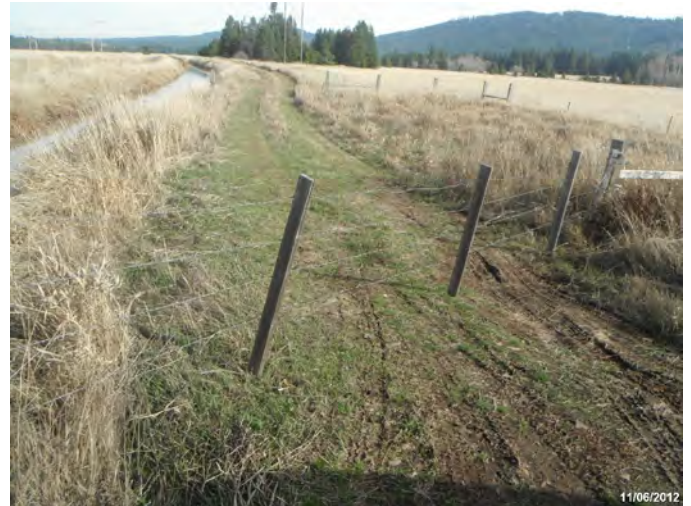
Photo: COLA_C4_0537 Route: 403-001-0.01
Metal Gate Barbed Wire
Asset# NA

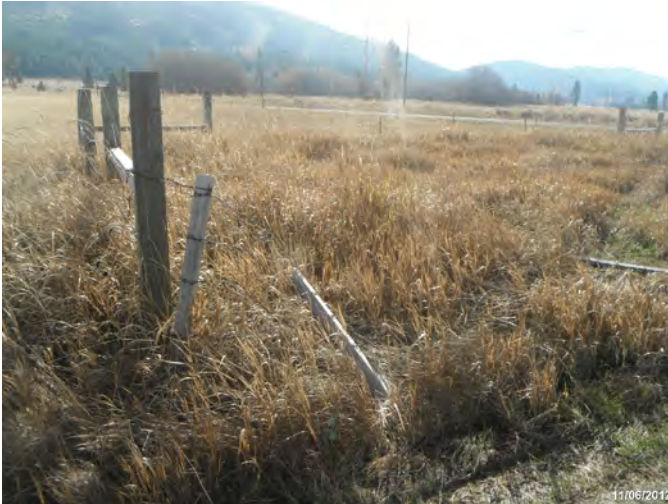
Photo: COLA_C4_0538 Route: 403-001-0.02
Metal Gate Barbed Wire
Asset# NA

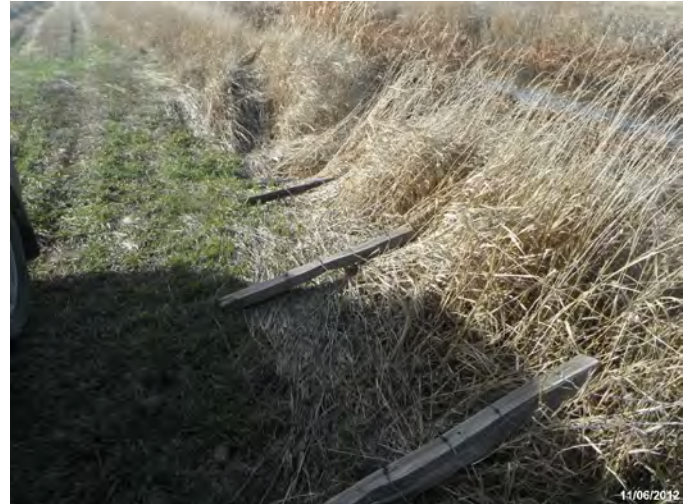
Photo: COLA_C4_0539 Route: 403-001-0.61
Metal Gate Barbed Wire
Asset# NA

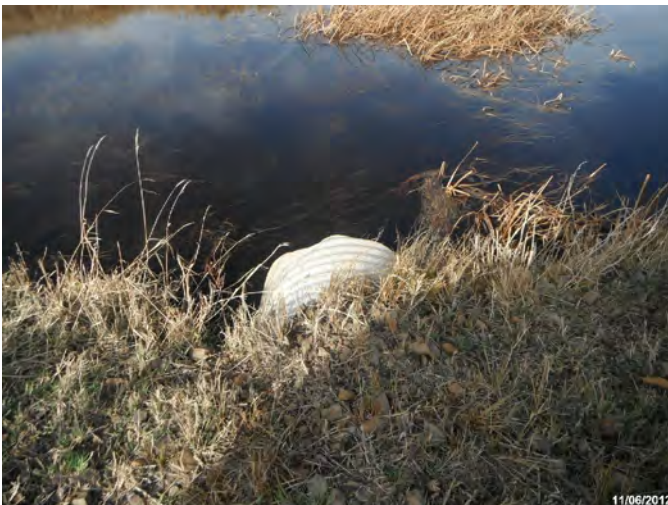
Photo: COLA_C4_0540 Route: 403-001-0.85
Metal WCS Flashboard Riser 25ft long 36in dia. 2ft deep
Asset# NA

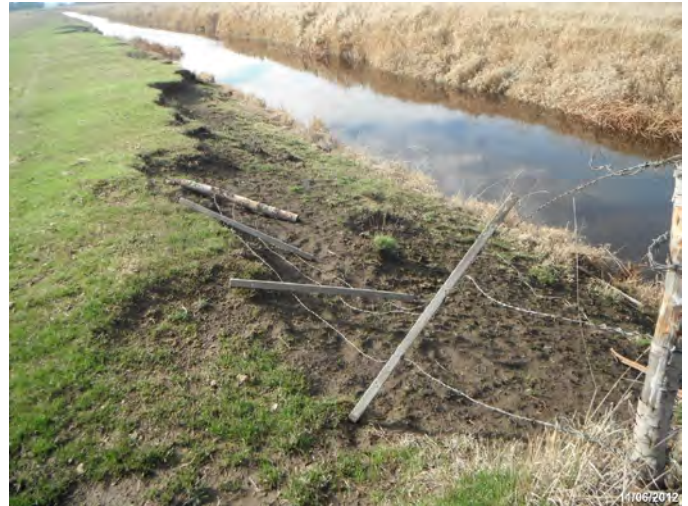
Photo: COLA_C4_0543 Route: 403-002-1.09
Metal Gate Barbed Wire
Asset# NA

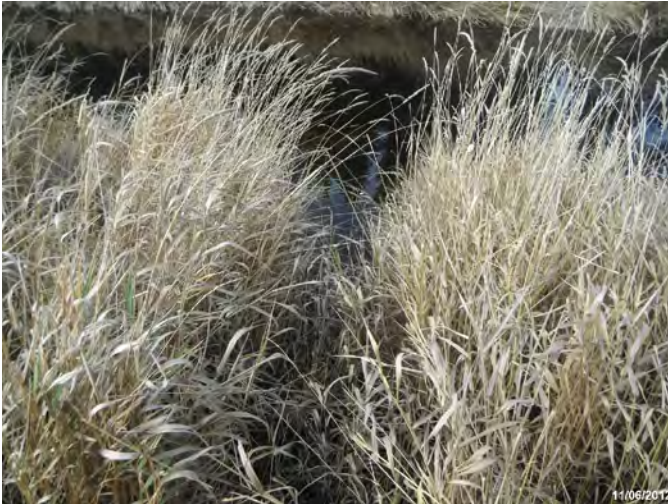
Photo: COLA_C4_0544 Route: 403-002-1.36
Metal WCS Flashboard Riser 35ft long 36in dia. 4ft deep
Asset# NA

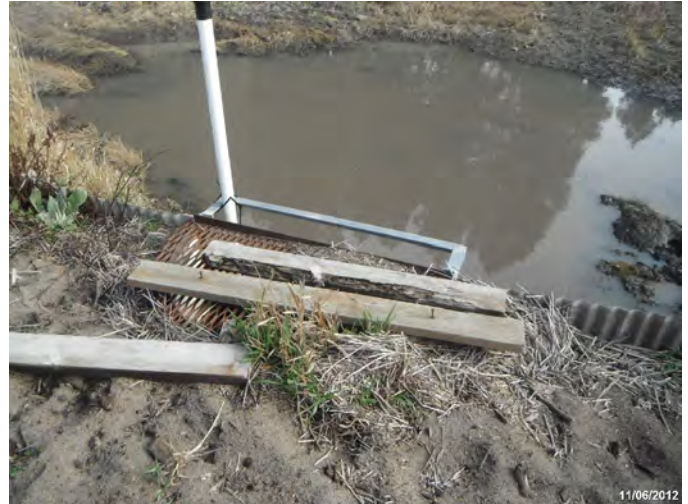
Photo: COLA_C4_0545 Route: 403-002-1.36
Metal WCS Flashboard Riser 35ft long 36in dia. 4ft deep
Asset# NA

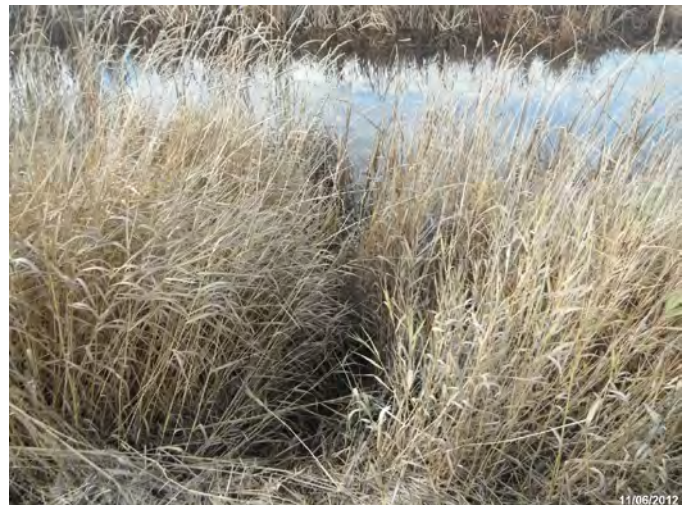
Photo: COLA_C4_0547 Route: 403-003-2.74
Metal WCS Flashboard Riser 30ft long 24in dia. 4ft deep
Asset# NA 8-021

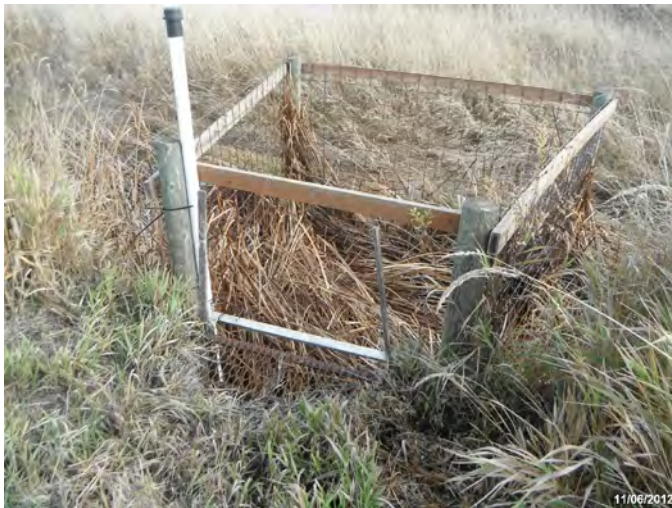
Photo: COLA_C4_0548 Route: 403-003-2.74
Metal WCS Flashboard Riser 30ft long 24in dia. 4ft deep
Asset# NA

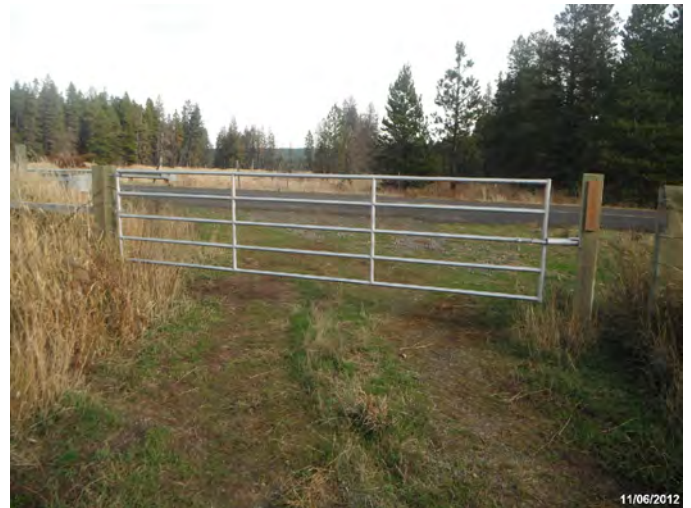
Photo: COLA_C4_0549 Route: 403-003-2.86
Metal Open Rail Gate
Asset# NA

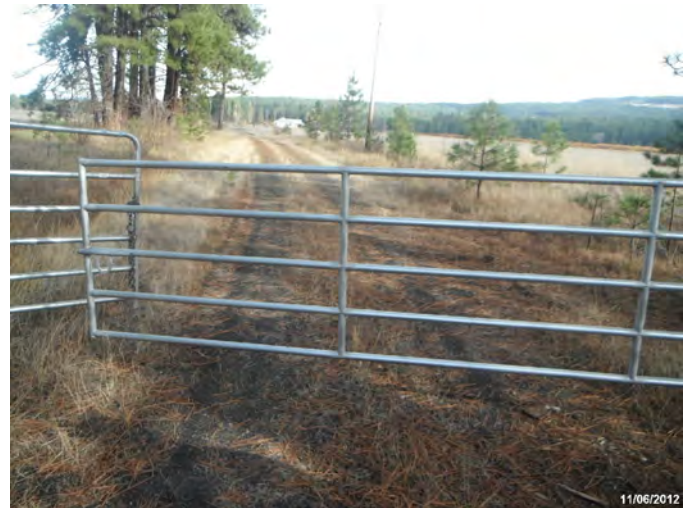
Photo: COLA_C4_0551 Route: 404-001-0.0
Metal Open Rail Gate
Asset# NA
